## Department of Environment, Land, Water and Planning

Ref: 2017-0087

### **FINDING OF NON-COMPLIANCE VICFORESTS TIMBER HARVESTING OPERATION AT COUPE 287-508-0009 (RIO)**

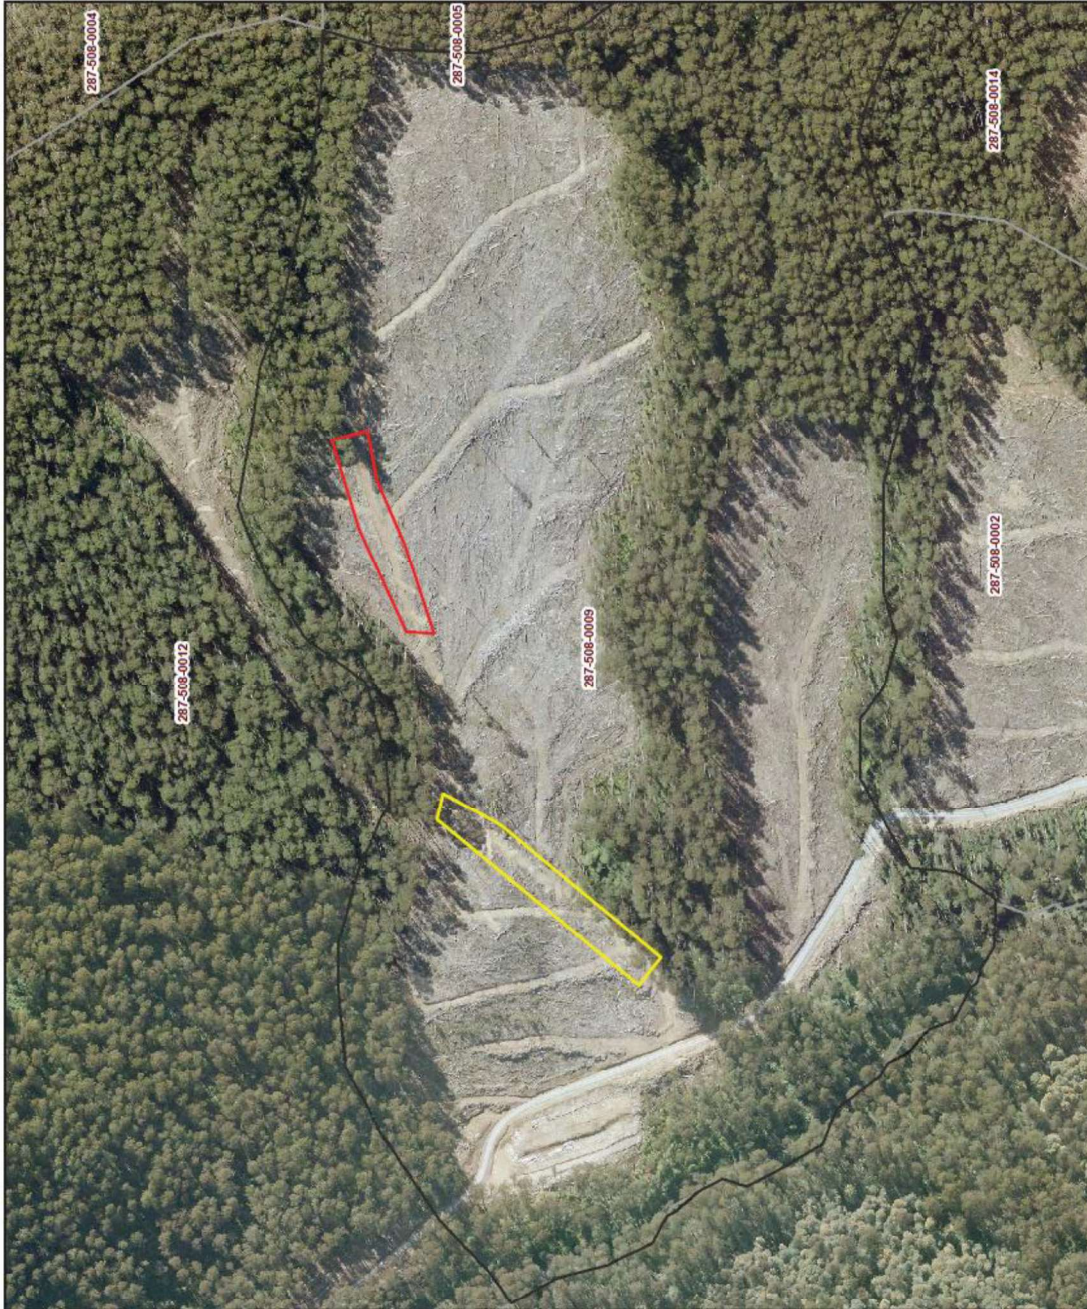
1. Map of erosion locations

*Snig track shown at Location No. 1 (Attachment 1):*

- The top section of the snig track has been constructed in an area of highly dispersive soils;
- The top section of the snig track has eroded, with sediment being mobilised and deposited up to 190 metres from the origin of the erosion;
- Significant rutting has occurred;
- Cross-drains have failed to adequately drain the track formation. This may be due to a lack of outlets, or due to damage from machinery, allowing water to return to the track formation and also be deposited on the snig track below.

*Snig Track shown at Location No. 2 (Attachment 1):*

- Cross-drains were not constructed on a 75-metre section of snig track, where the slope exceeded 20 degrees;
- Three cross-drains below the un-drained 75-metre section of snig track have failed to adequately drain the track formation due to blocked outlets, allowing water to overtop the 'bar' and return to the track;
- These three cross-drains have sustained significant erosion, up to 0.5-metre-deep, within the track formation.

Note: the classification of water quality risk by VicForests as 'low' was confirmed by independent advice to be appropriate. The area at Location 1 subject to the significant erosion was an isolated area of highly dispersive soil, however it was not extensive enough to alter the overall soil classification for Rio coupe.

- The eroded sediment did not in this instance impact on a waterway, or other protected value;
- Rehabilitation works have been voluntarily undertaken by VicForests; and
- VicForests' has made a voluntary undertaking to the OCR to undertake a number of actions including:
  - quarterly inspection and monitoring of the erosion, including identifying actions to manage erosion and threats to soil stability;
  - provision of an inspection report to the OCR following each inspection; and
  - additional soil management training for staff and contractors.

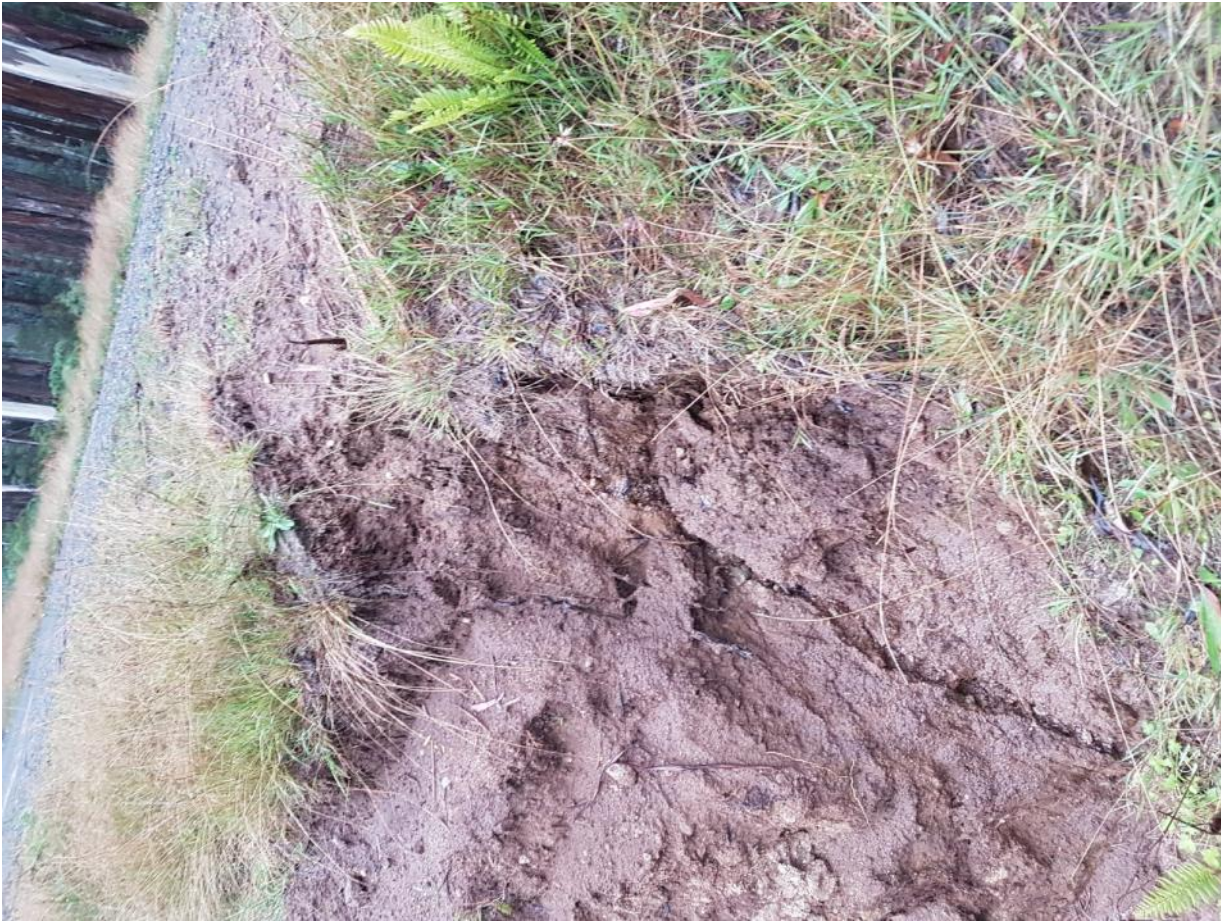
I attach some photographs taken towards the tail end of this rain event (6/4) along Snobs Creek Rd just south of Snobs Bridge (in coupes Shackle, Snobs 13 and Snobs 14) showing one of several overflowing silt traps, and a road shoulder collapse into a culvert pit (Att 1). Snobs Creek Falls was noticeably muddy. These attachments are strong evidence of a breach of MSPs Clauses 6.2.5.3 and 6.3.1.2.

Road verge collapse into culvert entry pit on Snobs Creek Road south of Snobs Bridge adjacent to active coupe

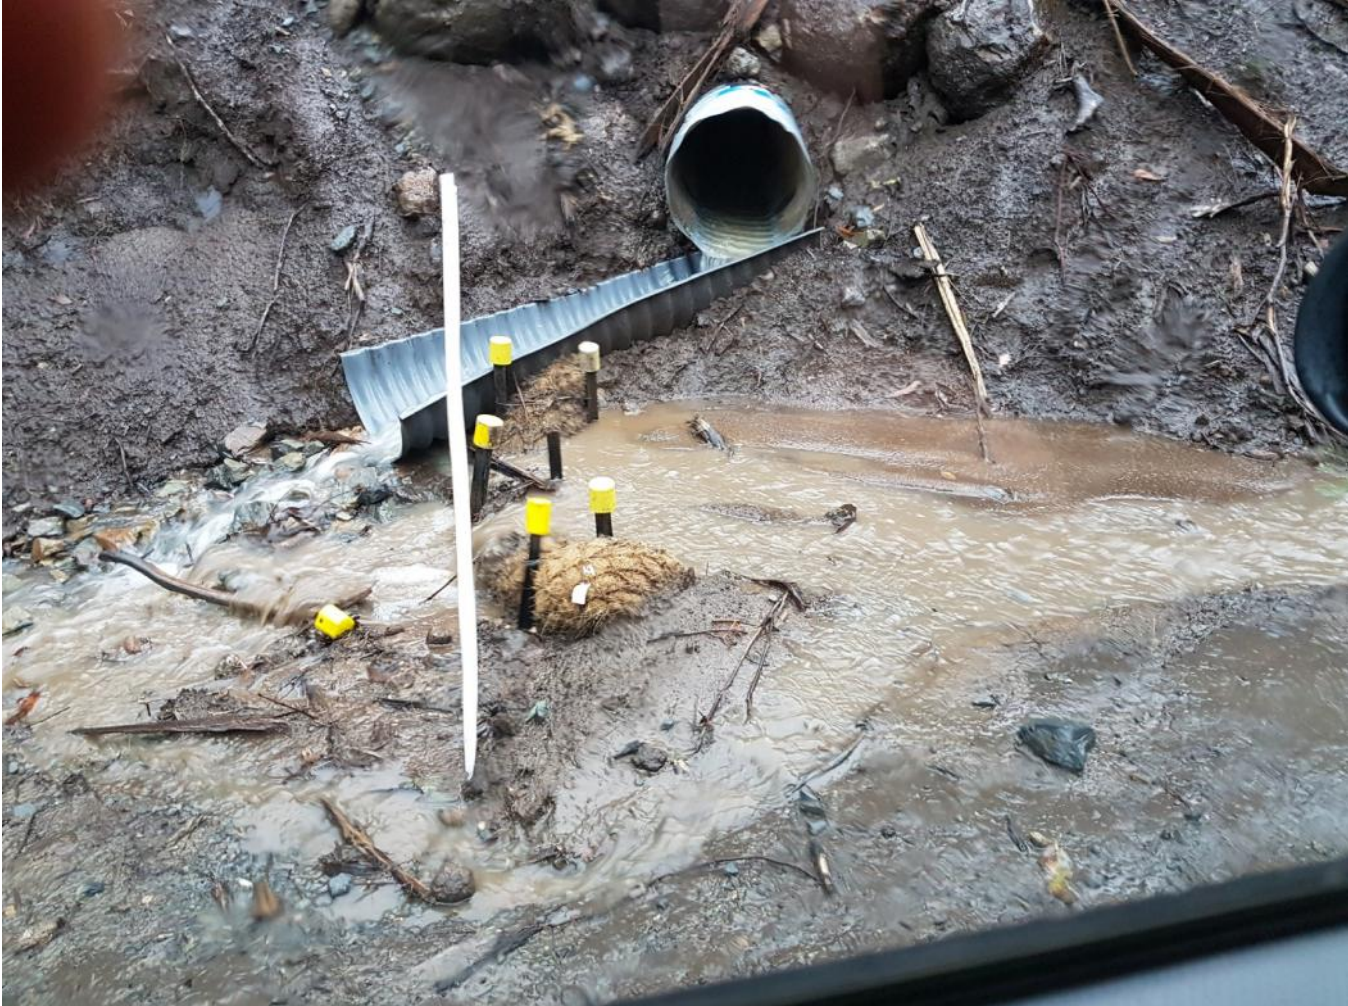
Overflowing silt trap on Snobs Creek Road south of Snobs Bridge adjacent to active coupe

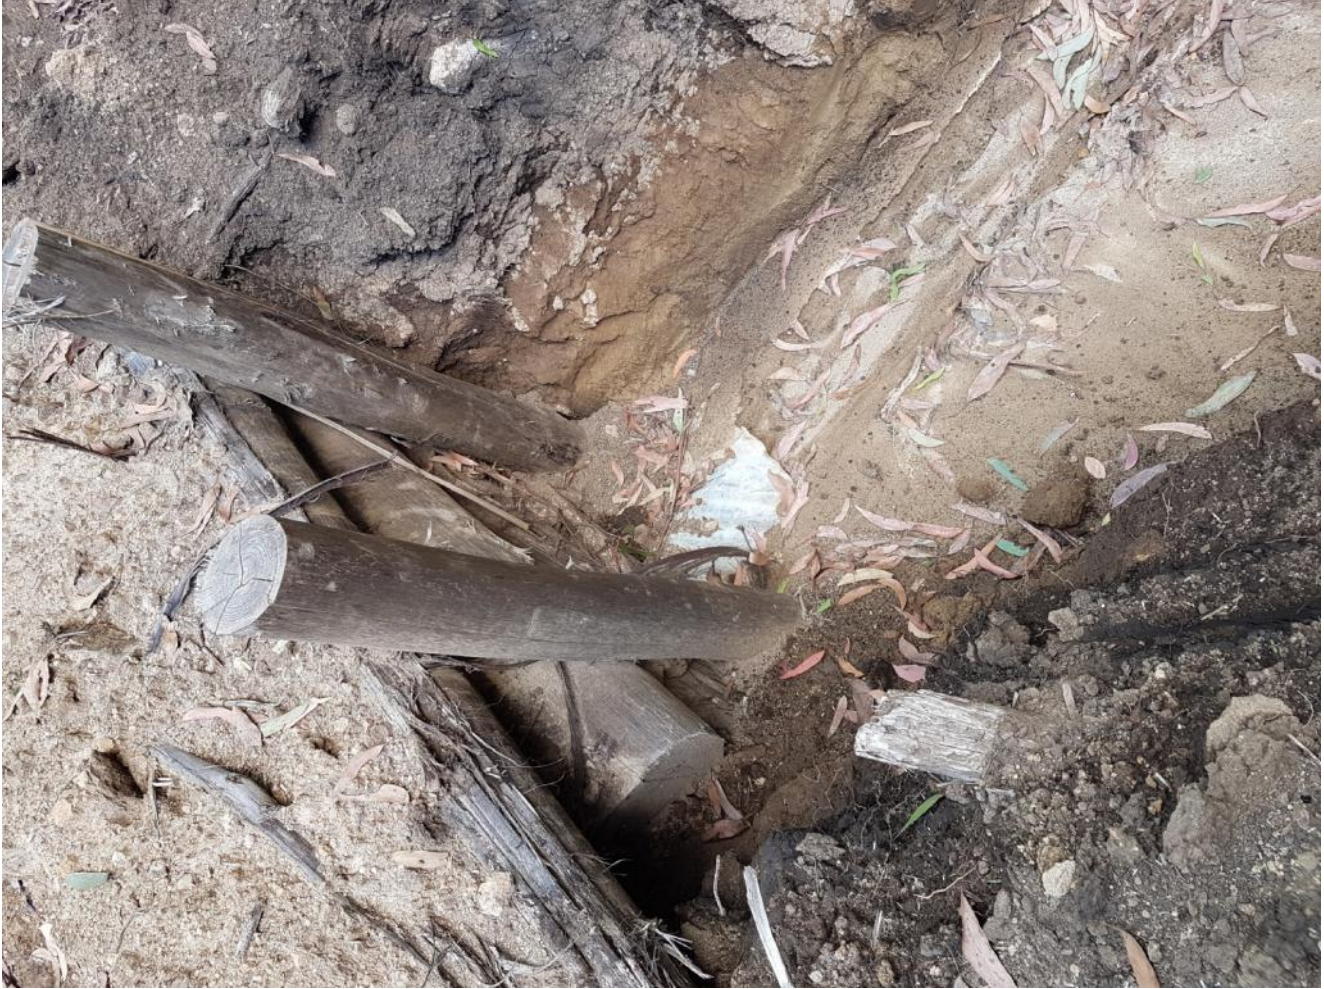
Three weeks earlier, on March 17, I inspected the access road to Gnu to examine the outcome of another major rain event on March 5. This coupe had been deserted soon after operations commenced due to a Leadbeaters possum sighting. A massive gully had formed in the incompletely surfaced access road and most of the culverts were silted up as the attached pictures show (Att 2). So although you did find VicForests guilty of a Code violation in relation to soil erosion (Case 2018-0087) the evidence shows that it continues to fail to take the proper erosion precautions. I consider that the distance

between culverts on this access road is longer than permitted under MSPs Clause 6.2.4.1 and that culverts were not constructed in accordance with MSPs Clause 6.2.5.3†

Blocked culvert exit under Gnu access road (17/3)

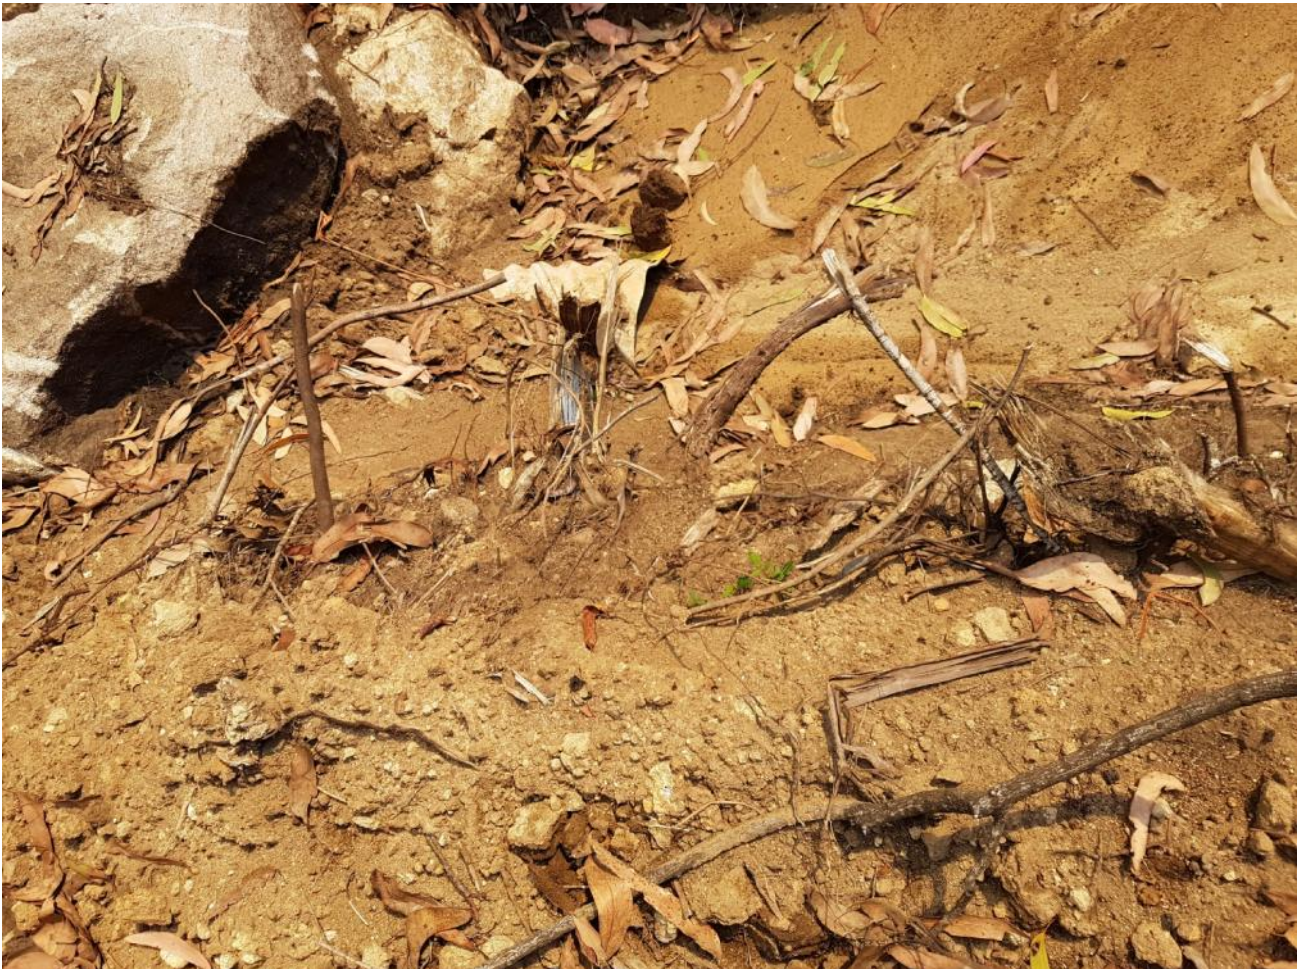
Another blocked culvert exit under Gnu access road (17/3)

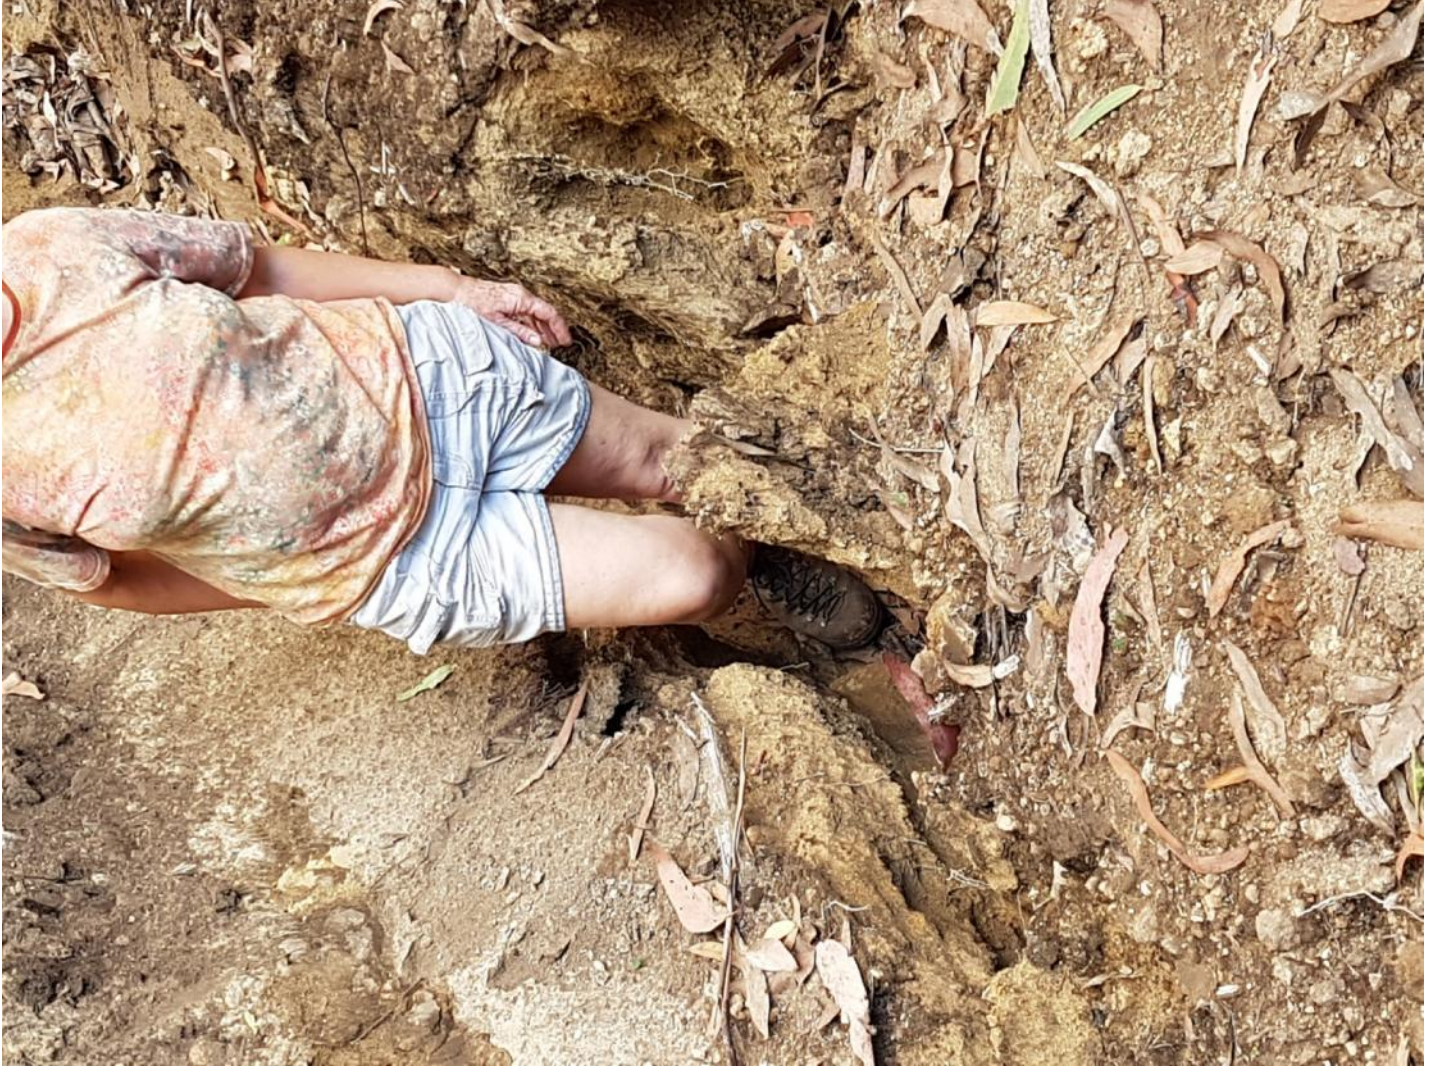
I visited this coupe yesterday to examine the impact of the current rain event and found the gully carved by the drainage flow even larger (no picture here since I was unaccompanied and could not demonstrate size with a human scale), although the culvert exits were still open, just.

Gully in road (17/3)

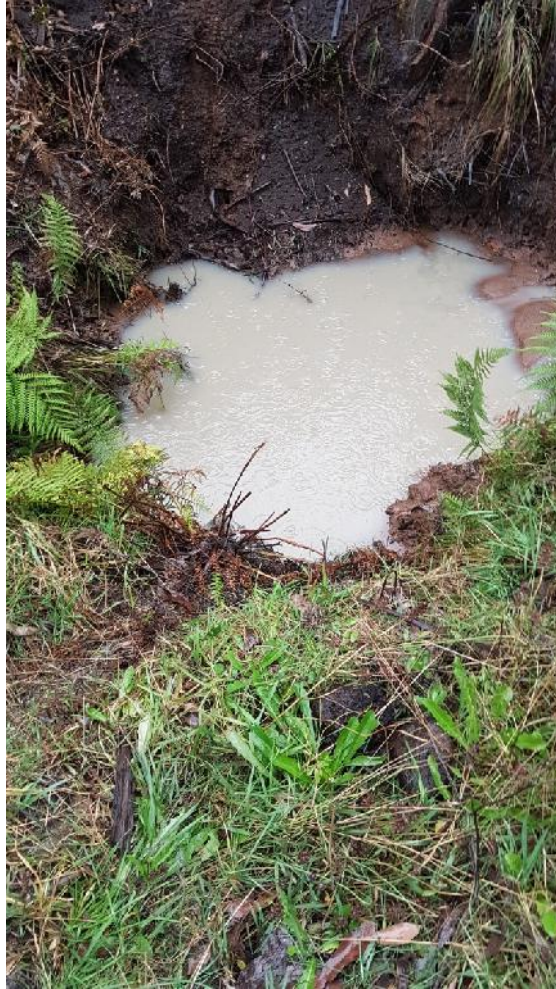
I also inspected the drains along Snobs Creek Road near the coupes south of the Snobs Bridge and this time observed two almost fully blocked culvert entry pits with evidence of at least one of them having previously overflowed. Failure to properly maintain drainage structures is in breach of MSPs Clause 6.3.1.2. (Att 3)

Almost fully blocked culvert entry under Snobs Creek Rd (11/4)

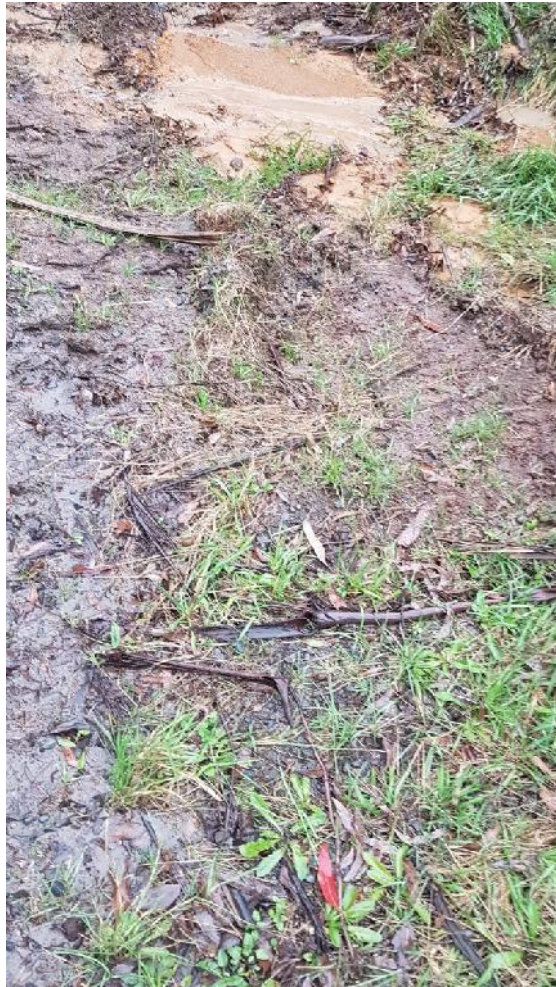
Evidence of overflow from culvert entry (above)

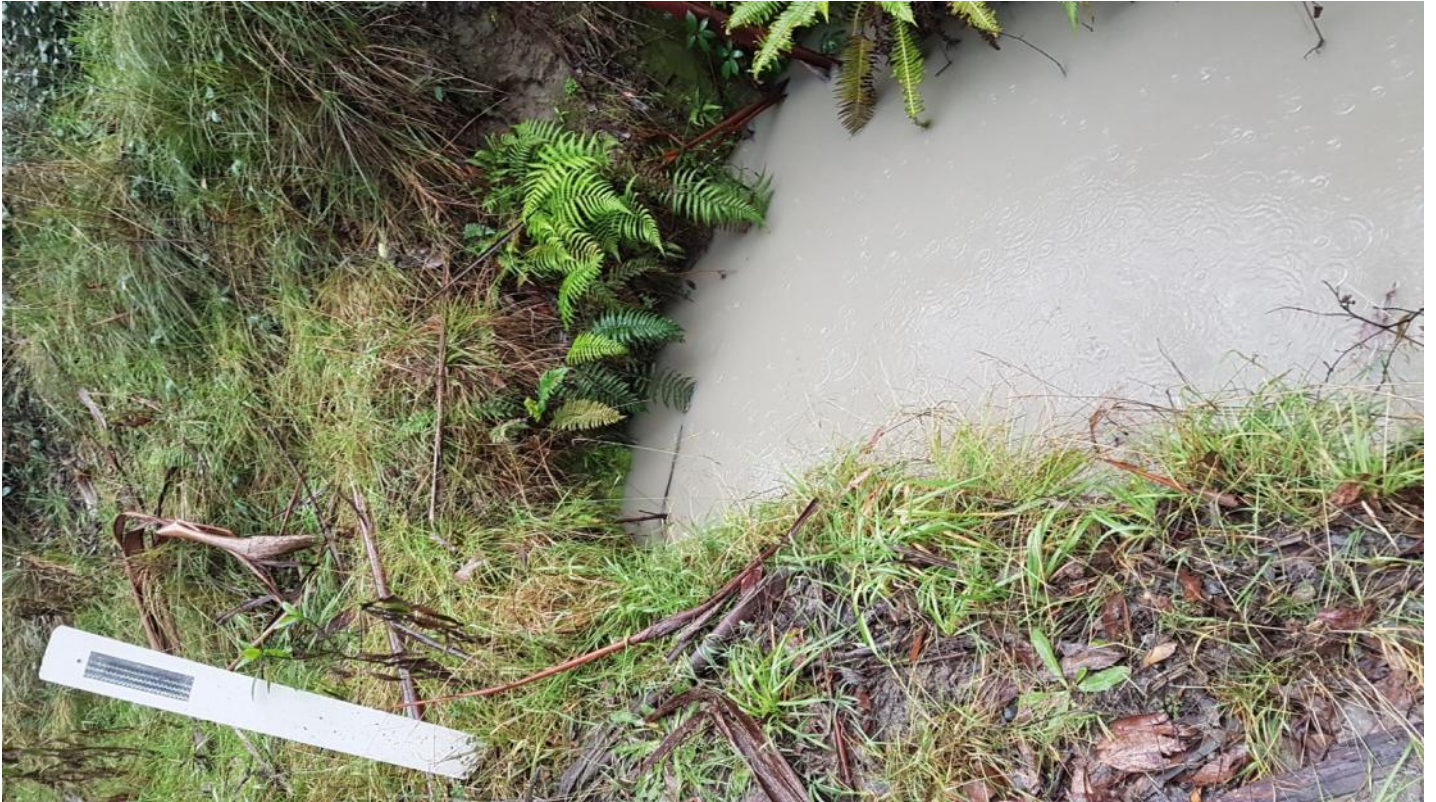
Another almost fully blocked culvert entry under Snobs Creek Rd (11/4)

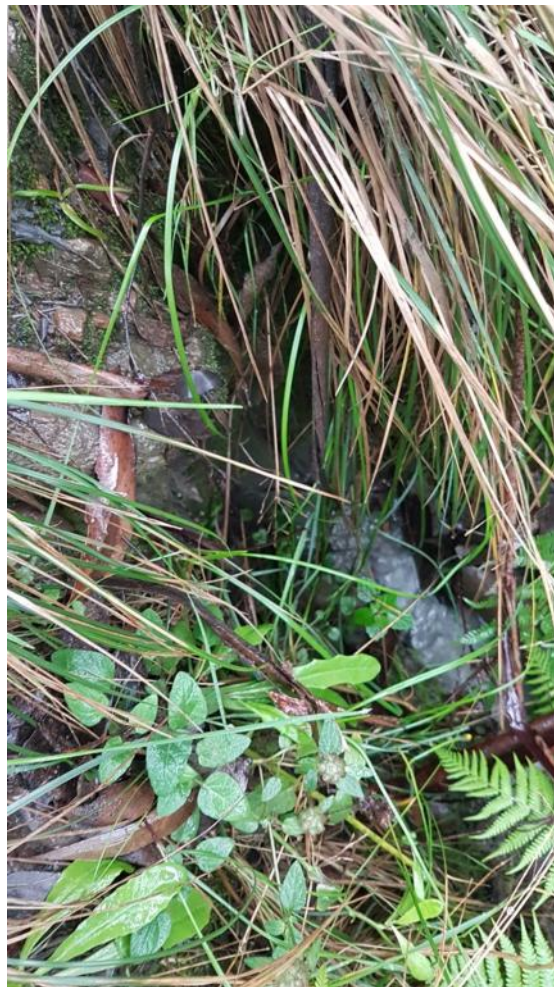
Evidence of low outflow from culvert (above)
